CERAMIC RELIABILITY FOR MICROTURBINE HOT-SECTION COMPONENTS

Reliability Evaluation of Microturbine Components

**CHARACTERIZATION OF ADVANCED
CERAMICS FOR INDUSTRIAL GAS TURBINE/
MICROTURBINE APPLICATIONS**

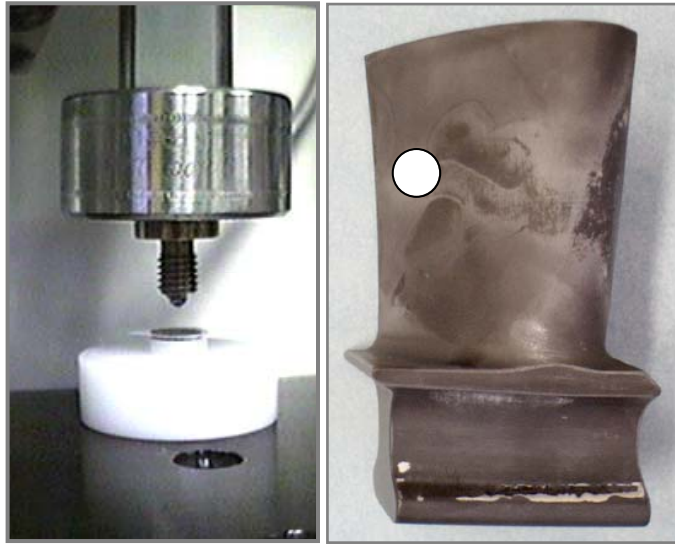
Figure 1. Biaxial testing system and samples extracted from airfoil of turbine blade.

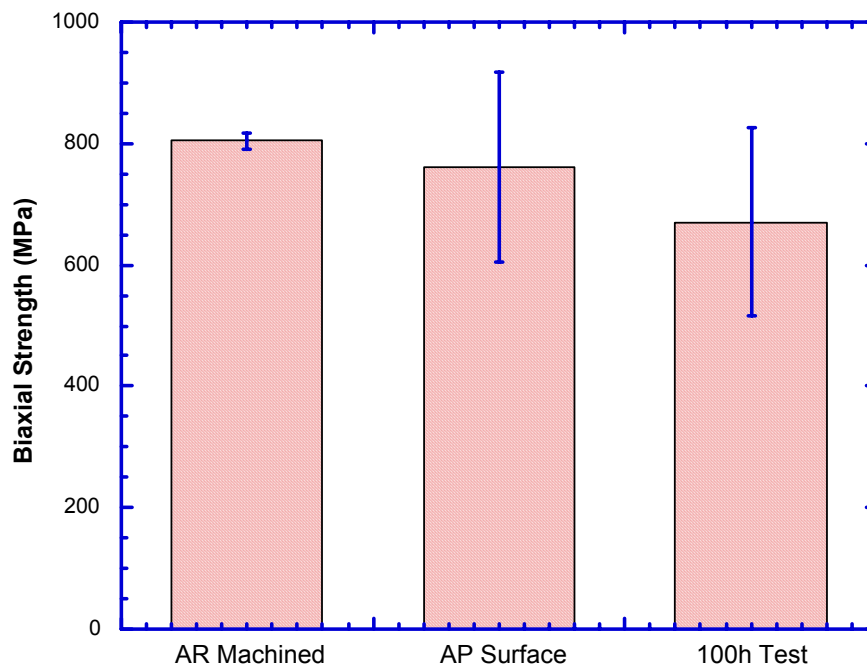
Figure 2. Biaxial strength of samples extracted from airfoil of SN281 turbine blade after 100h engine test.

Studies of mechanical properties of biaxial samples extracted from SN281 silicon nitride turbine blades after 100 h engine test at Solar Turbines, Inc., were completed during this reporting period. The biaxial flexure strength was measured using the ball-on-ring arrangement, as shown in Figure 1. Specimens were mainly machined from both the suction (convex) side of airfoil surfaces as well as dovetail region by first diamond core drilling small cylinders having nominal diameters of 5.5 mm (Fig. 1). Each cylinder was then machined on one face only until the thickness was 0.4 to 0.5 mm. In this way, one face of each specimen always consisted of the exposed (or as-processed) surface of the airfoil. During testing, this exposed (or as-processed) surface was loaded in tension. Note that for SN281 blade specimens with as-processed and machined surface were machined from the dovetail region. The data reported were the average value of at least 3-5 test specimens. The mechanical results showed that the samples with as-processed surface exhibited similar strength to those with machined surface, indicative of good green machining process (Fig. 2). Also, the 100-h test samples from airfoil region exhibited 12% lower strength than those extracted from the dovetail region, similar to those previously reported for SN88 and SN282 nozzles. The results suggest that the 100-h engine test has minor influence

on the mechanical strength of SN281 silicon nitride blades. The minor decrease in strength could result from the increased roughness of airfoil surface resulting from engine test.

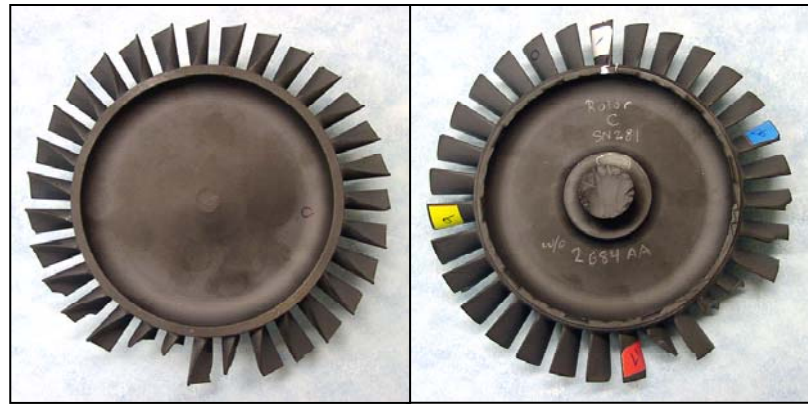
Figure 3. Photo show the as-received UTRC Kyocera SN281 microturbine rotor.

Evaluation of mechanical properties of samples machined from UTRC SN281 microturbine rotor was completed during this reporting period. The UTRC SN281 microturbine rotor was fabricated by Kyocera Industrial Ceramics Corp. (KICC), Vancouver, WA (See Figure 3). The UTRC microturbine rotor is 15 cm in diameter and contains 31 blades. Note that chipping and fracture of some airfoils occurred during the rotor processing. All biaxial disk samples were tested with as-processed surface. Figure 4 shows the uncensored strength distribution of biaxial disks extracted from UTRC SN281 microturbine rotor. Mechanical results showed that SN281 biaxial specimens exhibited a characteristic strength of 548 MPa and with a Weibull modulus of 14.2. Fractography analysis will be carried out to identify the strength limiting flaws and provide feedback to KICC for processing modification.

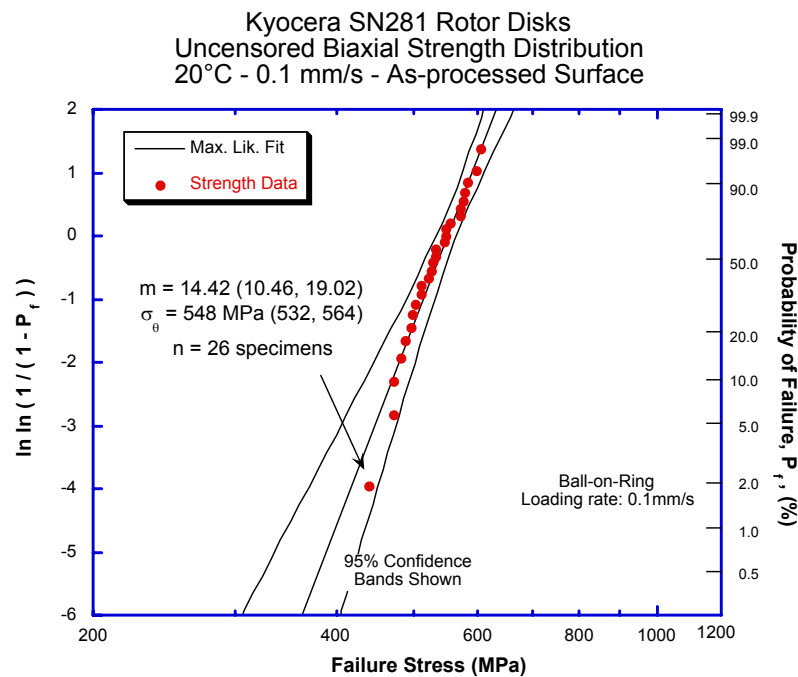
Figure 4. Uncensored biaxial strength distribution at 20°C of biaxial disks machined from UTRC SN281 microturbine rotor.

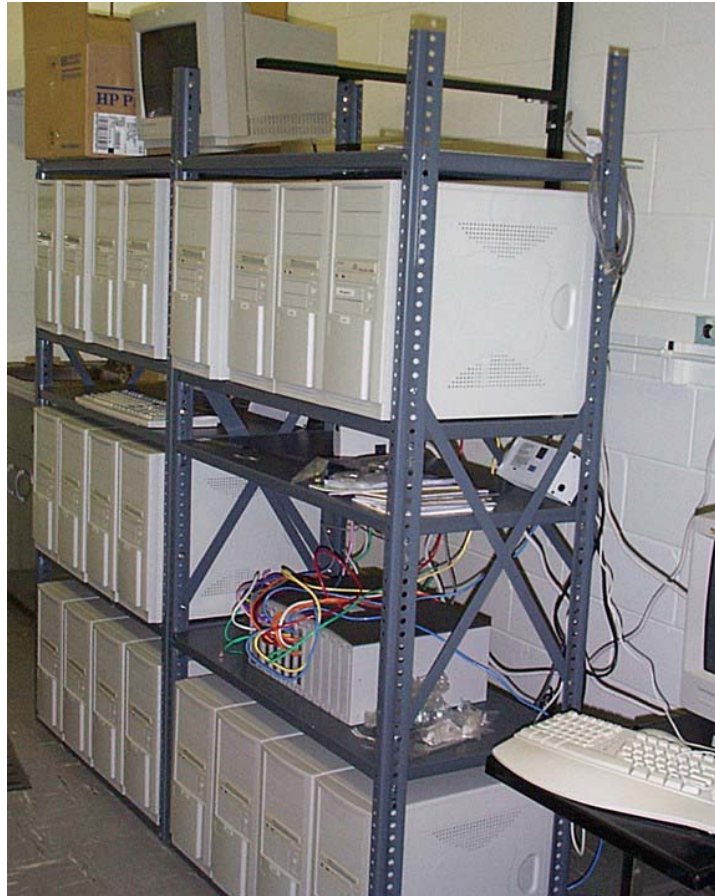
Fig. 1. Photograph of installed 18-node Beowolf Cluster for high speed X-ray tomography.

This period, in a cooperative effort with the Basic Sciences Division-Materials (BSD-M) here at Argonne, we assembled and installed a new 18-node Beowolf computer cluster as shown in Fig. 1. The purpose of this cluster is to allow us to do very high speed 3D X-ray reconstructions using the massive data sets that are being collected from the large area flat panel X-ray detectors. The cooperation with the BSD-M involved the fact that they provided all the processors and we provided the network cards, the chassis and primary node monitor and keyboard. To provide an example of the data set size that needs to be handled by the computer, consider that the flat panel has a 2000 by 2000 array and behind each pixel is a 2-byte dynamic range or 8-megabytes of data per projection. Then, if at a minimum, 1000 projections are taken, this is 8-gigabytes of data for this X-ray volume data set. In fact it likely that 1500 projections would be taken so the data set size would increase by 50% to 12-Gigabytes. Thus, this is a very necessary aspect as we push for the high-speed large volume CT.

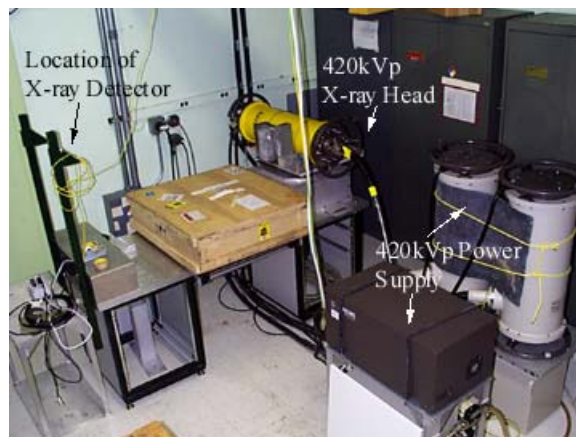
Fig. 2. Photograph of the recently installed 420 KVp X-ray head.

This period, the Phillips 420 KVp X-ray head system that was moved from Oak Ridge National Laboratory last period was installed as shown in the photograph of Fig. 2. This capability now allows the Argonne-developed 3D X-ray imaging technology to be implemented on large ceramic components under development for the microturbine hot section components.

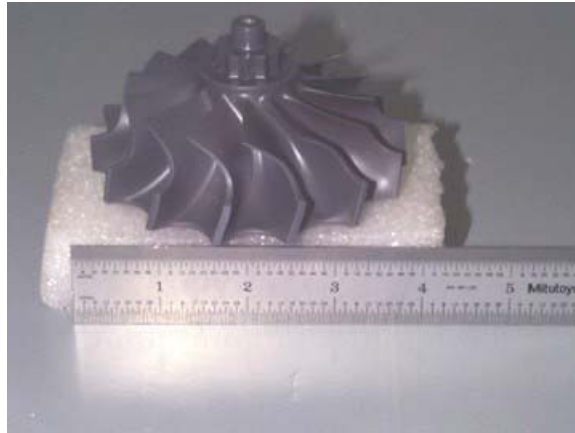
Fig. 3. Photograph of Ingersol-Rand Rotor.

Cooperative work started this period with Ingersol-Rand Energy Systems. A dense rotor, see Fig. 3, was received for initial NDE examination. This is made by Kyocera and was sent to us for initial exploratory NDE studies. One item of interest to us was to establish the necessary X-ray energy to penetrate the materials. Our previous experience was that the 320 X-ray head would not be sufficient and was a major reason we needed the 420KVp system. Figure 4 shows a projection radiograph taken with the 320 KVp X-ray head showing total lack of penetration in the lower region. While the 420KVp system was operational, we did not have a detector available on the 420 system at the time of this report. We will demonstrate the penetration next period using the 420 KVp head.

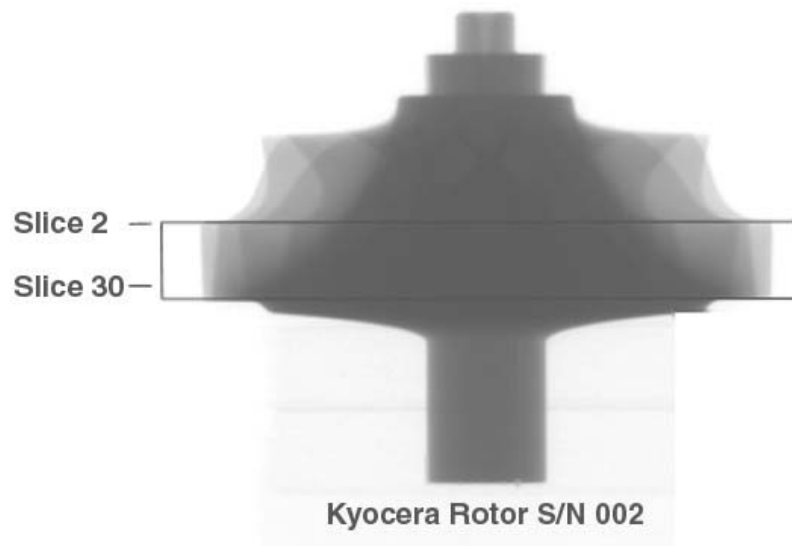
Fig. 4. Projection X-ray radiograph of the Ingersol-Rand rotor of Fig. 3. Note the lack of penetration at 320 KVp in the lower section.

One X-ray CT section for this Kyocera rotor is shown in Figure 5. This was taken at the axial location shown in Fig. 4. While this is an “uneventful” CT image (it has no features of distinction) it demonstrates again the cross-sectioning capability of the CT NDE method.

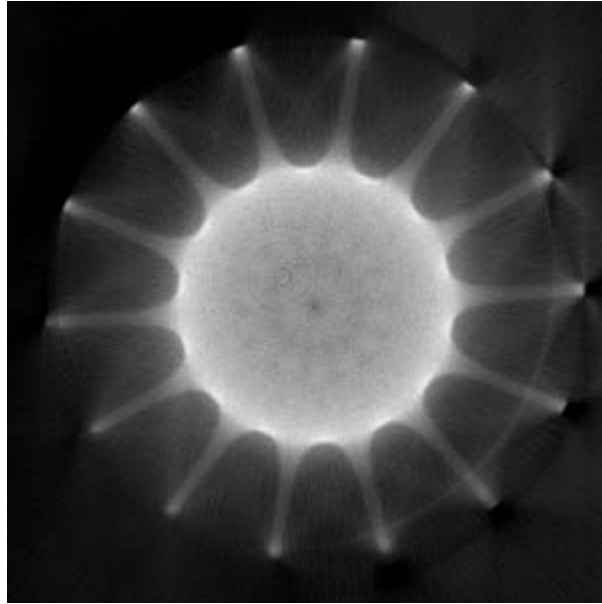
Fig. 5. One X-ray tomographic cross-section slice-2, taken of the rotor of Fig. 3. Note location of slice-2 from Fig. 4.

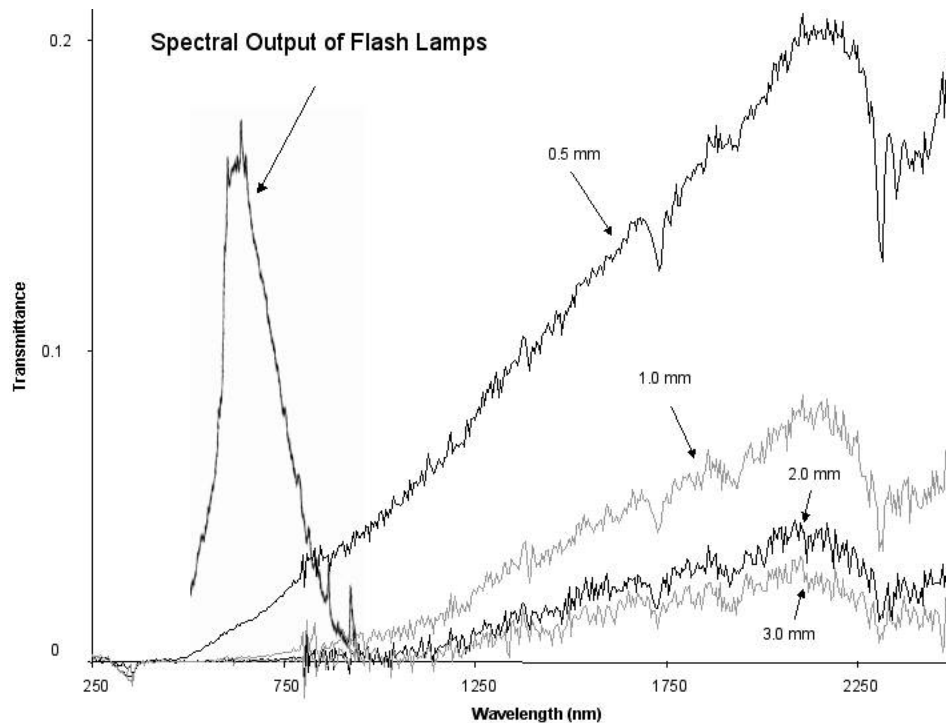
Fig. 6. Optical transmission characteristics of AS/N720 oxide/oxide composite.

Work continued this period relative to development of NDE technology for oxide-based ceramic composites. This work continues to be done in conjunction with Dr. Dave Carruthers as well as with Composite Optics, Inc-Ceramics. One issue that has been of concern with the use of oxide/oxide composites from an NDE point of view is that, when trying to use thermal imaging technology, there is an issue of the optical translucency of the oxide materials. In order to better understand this effect, this period we produced a step wedge of AS/N720 material. The step wedge was about 10 mm wide by about 50 mm long. Steps were ground such that each step was about 10 mm by 10 mm. The thickness of the steps ranged from 0.5 mm to the overall thickness that was about 3 mm. The optical transmission was then established as a function of the step wedge thickness. The results are shown in Fig. 6.

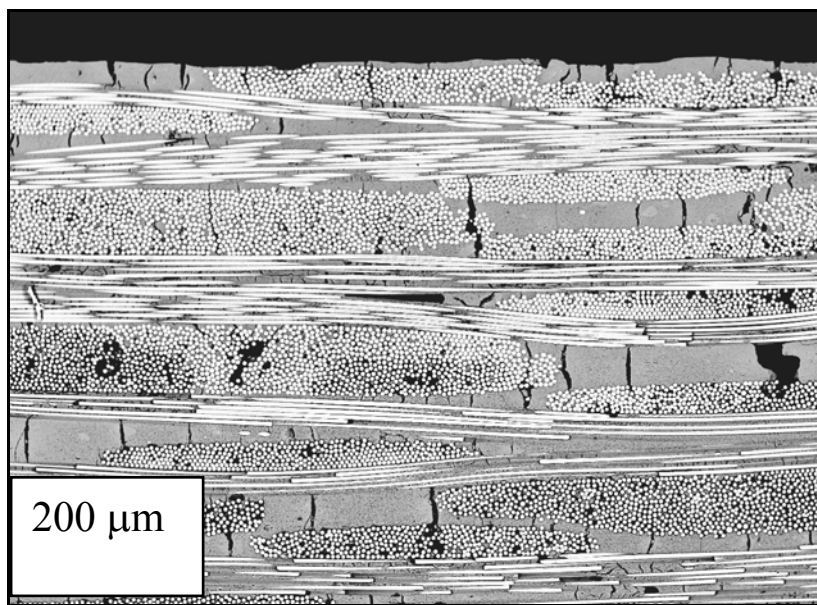
Figure 2. Matrix densification within fiber tows was less than that between fiber tows.

Several characterization techniques will be utilized to fully evaluate and discern and microstructural changes that occurred to the oxide/oxide composite during long-term exposure to high water-vapor pressures. These include NDE (at Argonne National Laboratory), scanning and transmission electron microscopy, and X-ray diffraction. The typical bulk microstructure of the composite material used for this study is shown in Figure 1. The oxide/oxide is characterized by a 2-D woven oxide fiber structure with a 0°/90° fiber lay-up. The oxide matrix appears to be relatively dense around the oxide fiber tows and is micro-cracked between and perpendicular to the tow surface. Matrix infiltration/densification between fibers within the tows is less than between the fiber tows themselves, as shown in Figure 2.

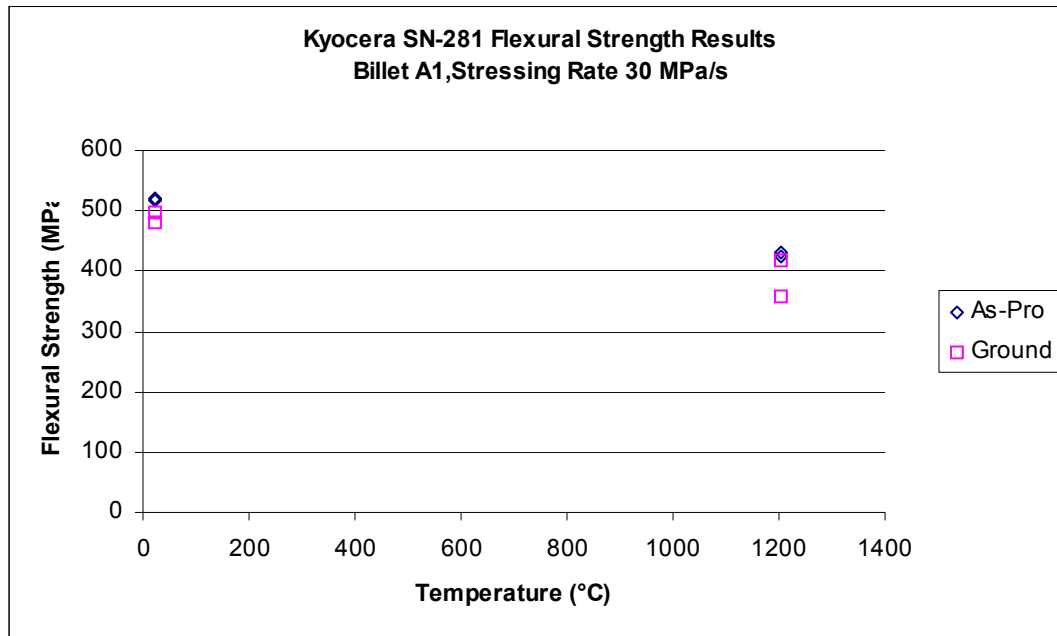
Figure 1. Flexural Strength of Kyocera SN 281 at room temperature and 1200°C

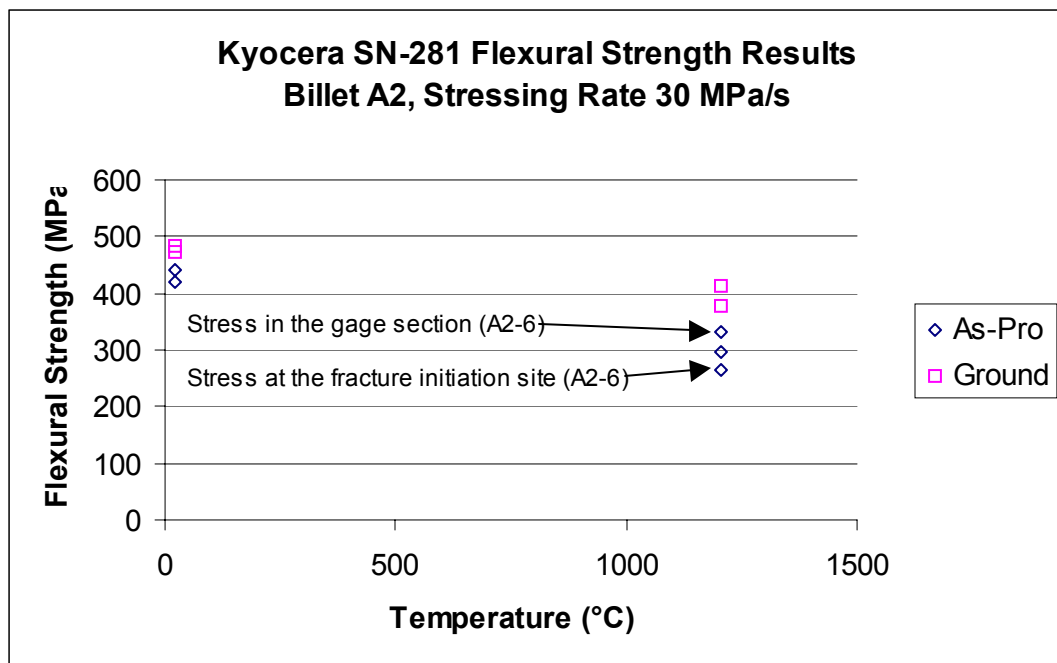
Figure 2. Flexural Strength of Kyocera SN 281 at Room Temperature and 1220°C

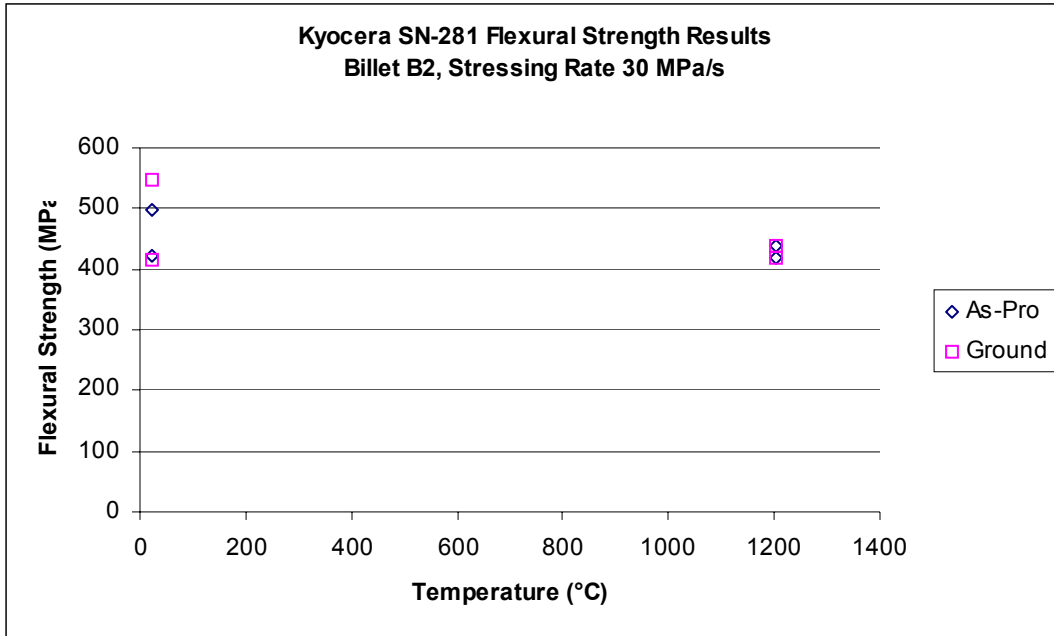
Figure 3. Flexural Strength of Kyocera SN281 at Room Temperature and 1200°C

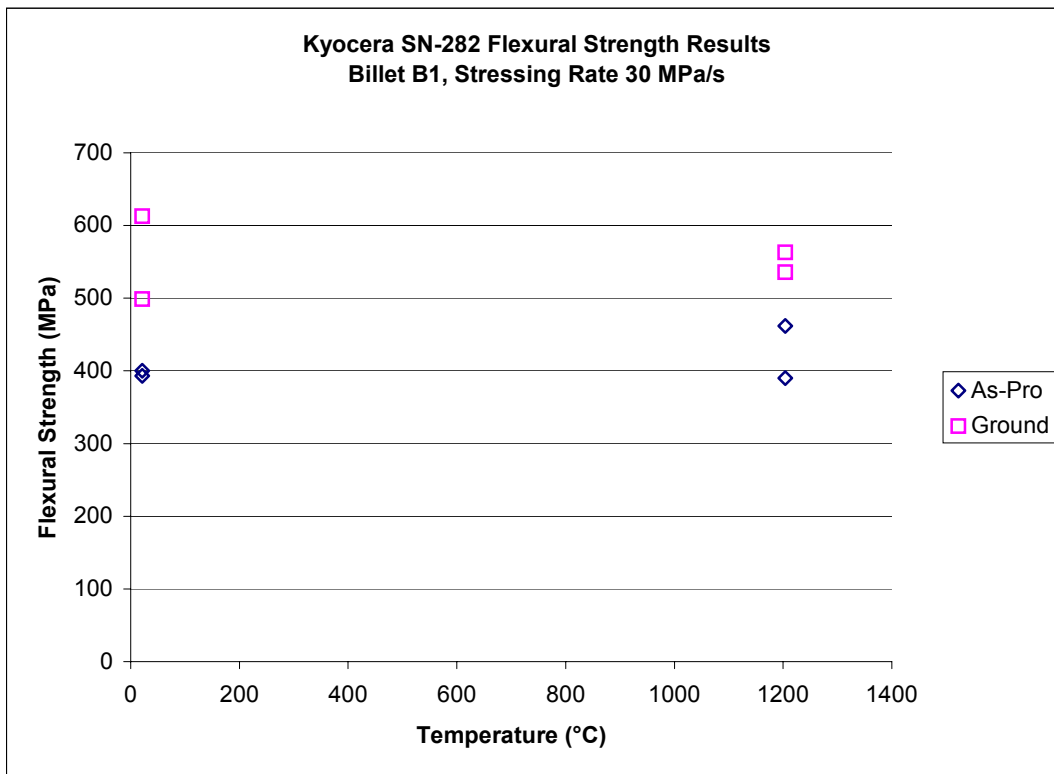
Figure 4. Strength of Kyocera SN282 at Room Temperature and 1200°C

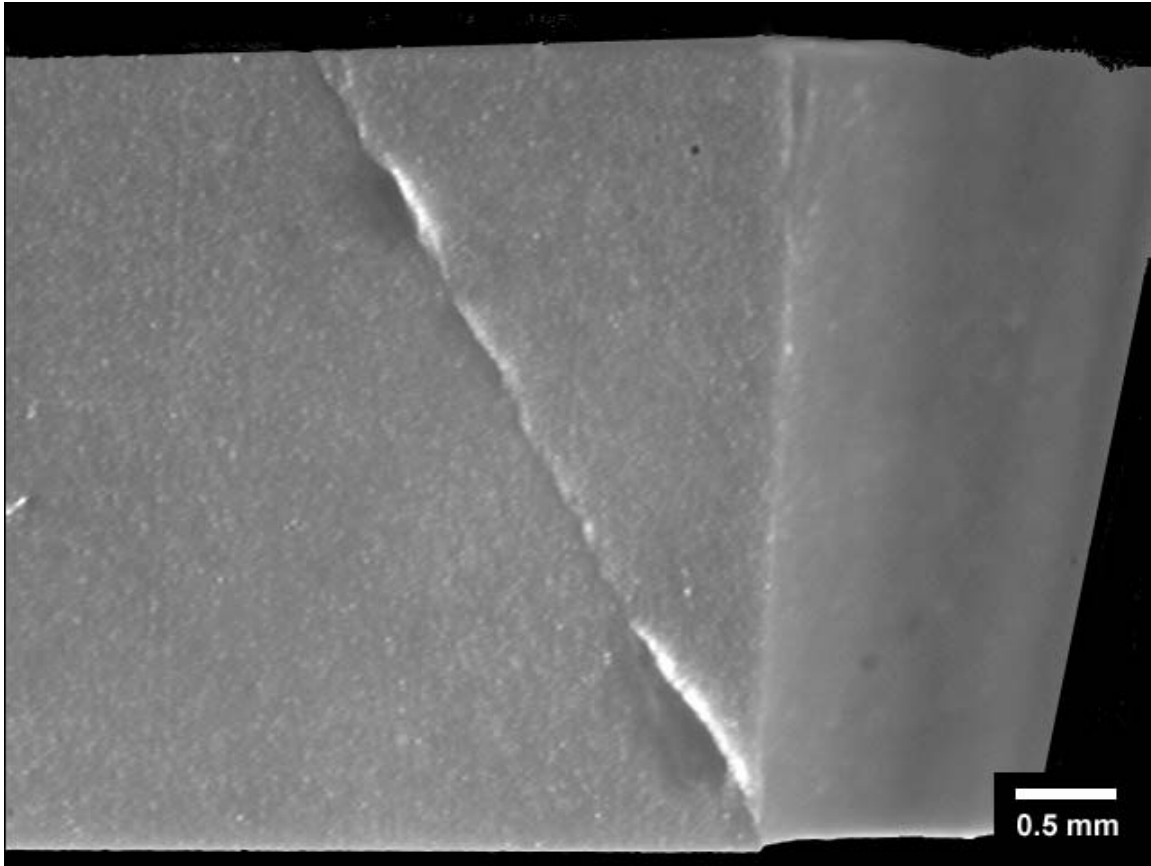
Figure 5. Example of Processing Defect on SN282 Silicon Nitride Billet

The as-processed surfaces were fairly rough. There were pits, scratches, “processing” lines and discolorations (see Figure 5). The bevels on these surfaces were very inconsistent along the length of the specimens and there were places where no bevel was present. The thickness also had a good deal of variation due to the inconsistent surface topography. The specimens that were ground on all surfaces also had a few pits and discolorations visible on the surface. Each specimen was examined using low power optical microscopy after testing. There were a number of large fine grain agglomerates noted on the fracture surfaces that appear to be the fracture initiation sites. Of the thirty-two specimens tested twenty-two failed at the surface, five failed at the edge, three were volume failures and one could not be identified. Two of the surface failures in the ground specimens initiated at pits. It appears the irregular surface topography could have influenced several of the as-processed specimens. One of these failed outside the gage section at a large depression in the surface. The 0.003 MP/s testing is under way and will be reported in the next quarterly report.

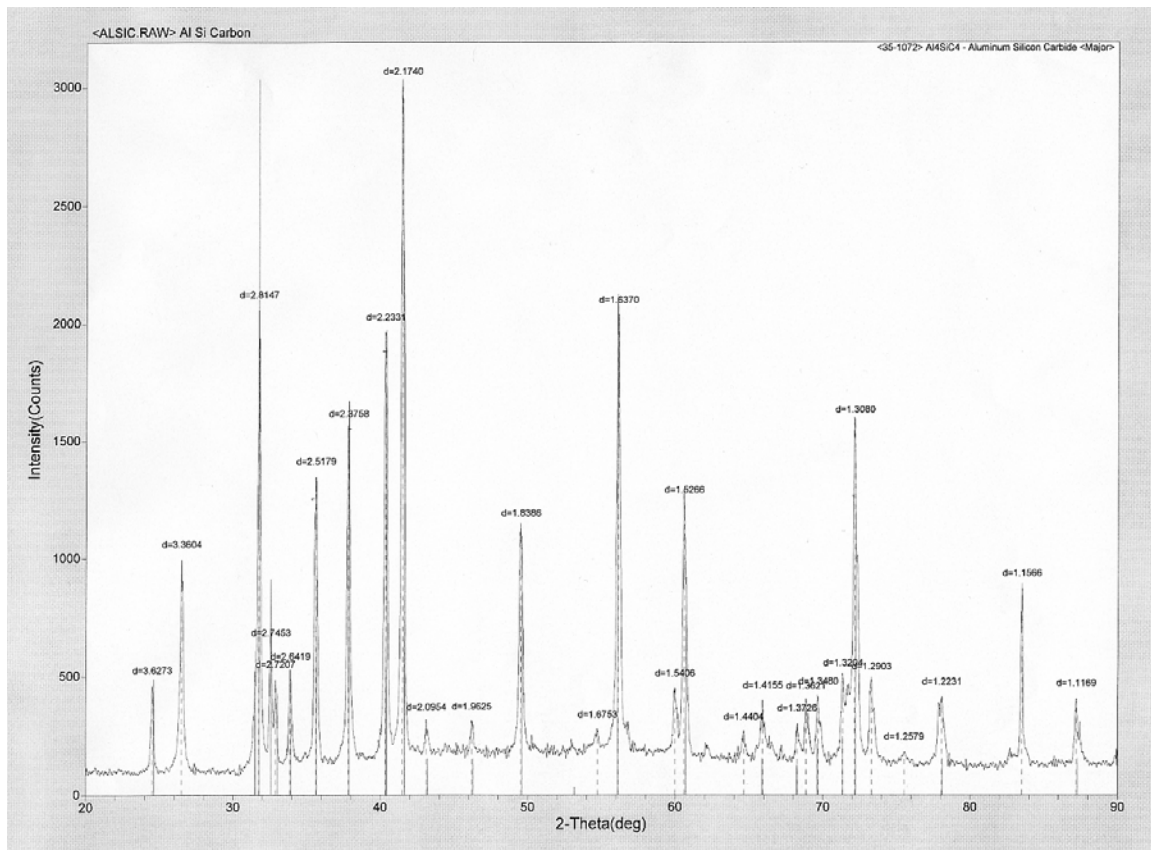
Figure 6. X Ray Diffraction Pattern of Sample from Experiment 1 showing Al_4SiC_4 peaks and small amount of silica at $d=3.36$

In the first experiment a 0.5in disc cold pressed at 15ksi was first heated to 600°C for 1 hr in argon then to 1800 for 1 hour. After 1 hour at 600°C the disc was cooled and examined. One could readily see that some of the aluminum – silicon eutectic has oozed out of the disc. Sample was put back into the furnace and heated to 1800°C for 1 hour. The sample had a good disc geometry with no signs of molten material having been formed. It appeared to be black on the outside with an orange interior. The outside ring was rich in silicon and carbon with little aluminum, while the inner material contained much more aluminum. It would appear that the outside ring was a reaction zone probably resulting from the sample being heated in a graphite die. The bulk of the material was further reexamined by X ray diffraction and found to be mainly aluminum silicon carbide with a small amount of silica since the high intensity silica peak is seen at $d = 3.36$.

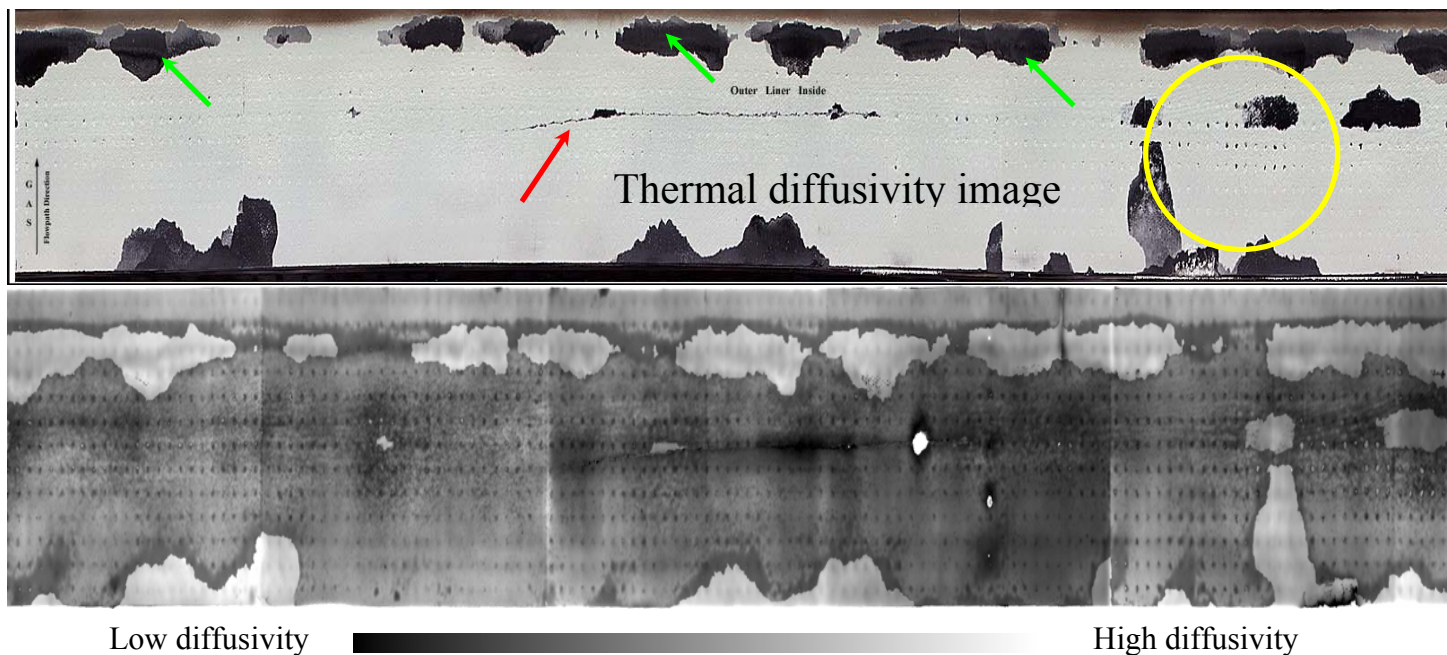
Figure 1. Photograph of outer liner gas-path surface after 15,144 h engine test at Malden Mills with the associated thermal diffusivity image. The red lines indicate the position of cracks in the liner on the thermal diffusivity image. The green arrows indicate EBC edge loss. The area circled shows a pattern of pinhole defects through EBC.

Figure 1 shows the correlation between the NDE thermal diffusivity data and the outer liner gas-path surface. Compared with similar images of the inner liner gas-path surface (see DEER Quarterly Report from October 1, 2002 – December 31, 2002), much more EBC loss occurred at the aft and fore edges on the outer liner (identified by green arrows in Figure 1). Also, less cracking was observed on the outer liner compared with extensive circumferential and aft-to-fore cracks observed on the inner liner. Many of the features observed on the gas-path surface of the Malden Mills outer liner were similar to those observed on a CVI outer liner field tested for 13,937 h at the Texaco engine test site in Bakersfield, CA (see DEER Quarterly Report from January 1, 2002 – March 31, 2002). Similar EBC edge loss was observed on the Texaco outer liner (due to the mechanical interference with metal liner holder). Other features observed on the Malden Mills outer liner, particularly the pattern of “pinhole” surface defects (see circled area on Figure 1) and BSAS recession across the center region of the liner, were identified and extensively characterized previously for the set of Texaco liners (see DEER Quarterly Report from January 1, 2002 – March 31, 2002).¹

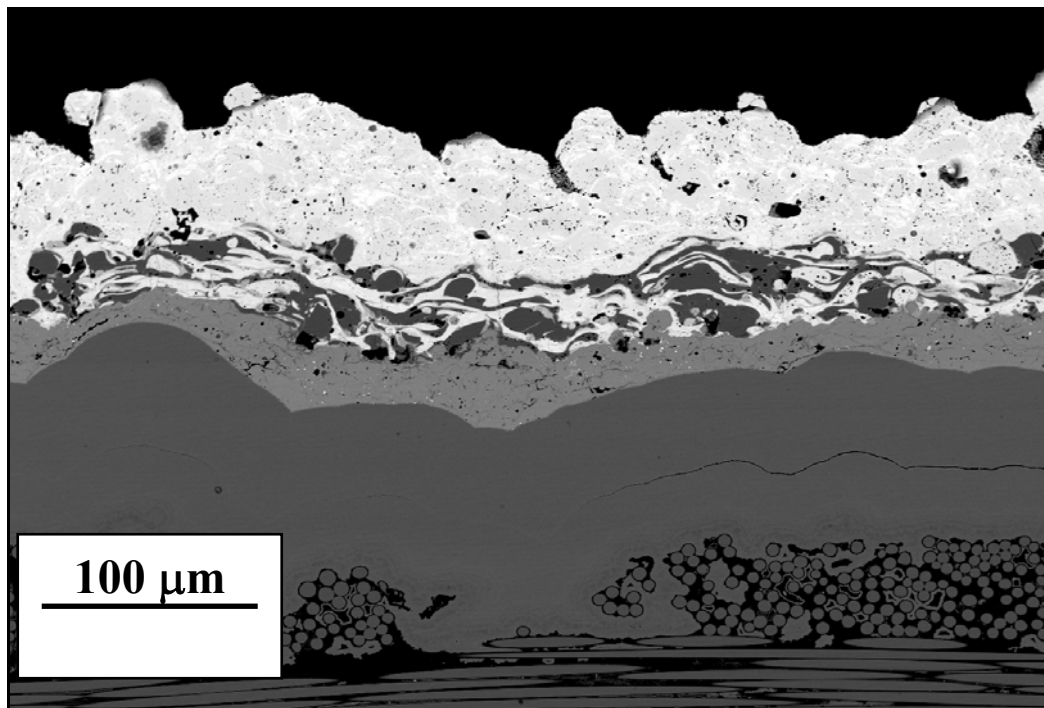
Figure 2. As-processed microstructure of BSAS/mullite+BSAS/Si EBC on outer liner used in Malden Mills engine test.

Unlike the non-optimized EBC applied to the inner liner (see DEER Quarterly Report from October 1, 2003 – December 31, 2003), the quality and microstructure of the as-processed EBC sprayed on the outer liner was very good, as shown in Figure 2. The BSAS top-coat (image was taken from the cool aft end of the liner which should be representative of the as-processed microstructure) was quite dense and uniform in thickness as were the mullite+BSAS mixed layer and Si bond coat. Much of the EBC along the center region of the outer liner appeared to have remained intact during >15,000 h engine testing. The BSAS top-coat of the EBC on the outer liner did experience measurable recession within the center portion of the liner, however, complete recession through the EBC and SiC seal coat to the CFCC was not observed (as has occurred on previous liners, especially in areas associated with fuel impingement). These observations were consistent with results presented previously for the EBC/CFCC liners engine tested at Texaco.¹
